<i>Seabed Sampling and Baited Camera Operations</i>	
Vessel	R/V Ocean Veritas
Summary Report Number	01
Operating equipment	MAXI Corer (8 core unit)
Date	24 September 2010
Completed casts (12 hr)	3
Report compiled by	Brian Critchley/Emily Gould

Seabed Sampling Locations

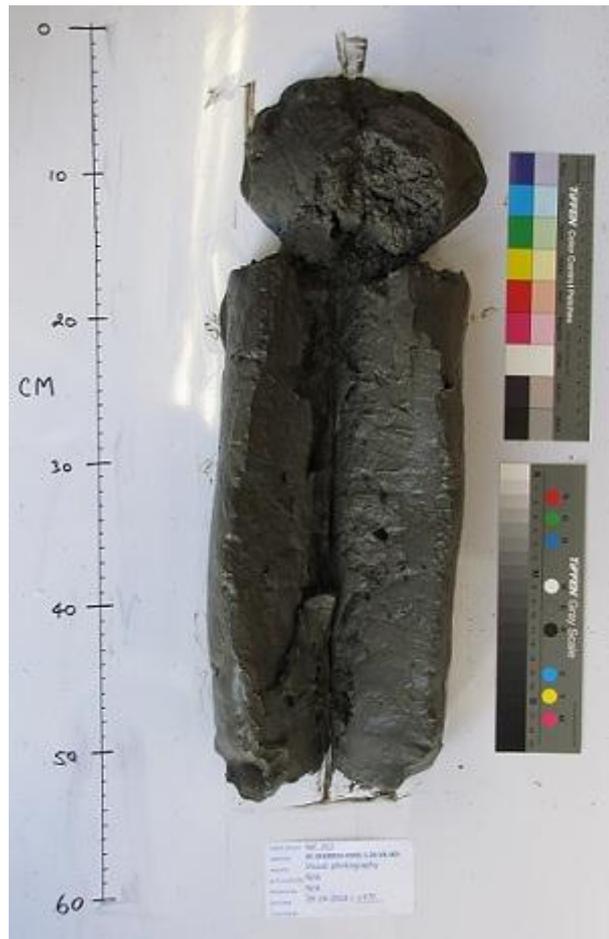
Station 1-20

Visible contamination: None

Offactable contamination: None

Description: Approx 10cm very soft olive/brown silty clay, gradual transition to 35cm soft olive/brown clay. Top 0-3 cm not examined as given to GC/MS for analysis.

Gas Chromatography & Mass Spectroscopy: The top 3cm of sediment core was sampled and analysed for EPA priority pollutant PAHs and Corexit 9500 dispersant. The sample was also screened for the source oil fingerprint. None of the target analytes were detected. No source oil was detected.

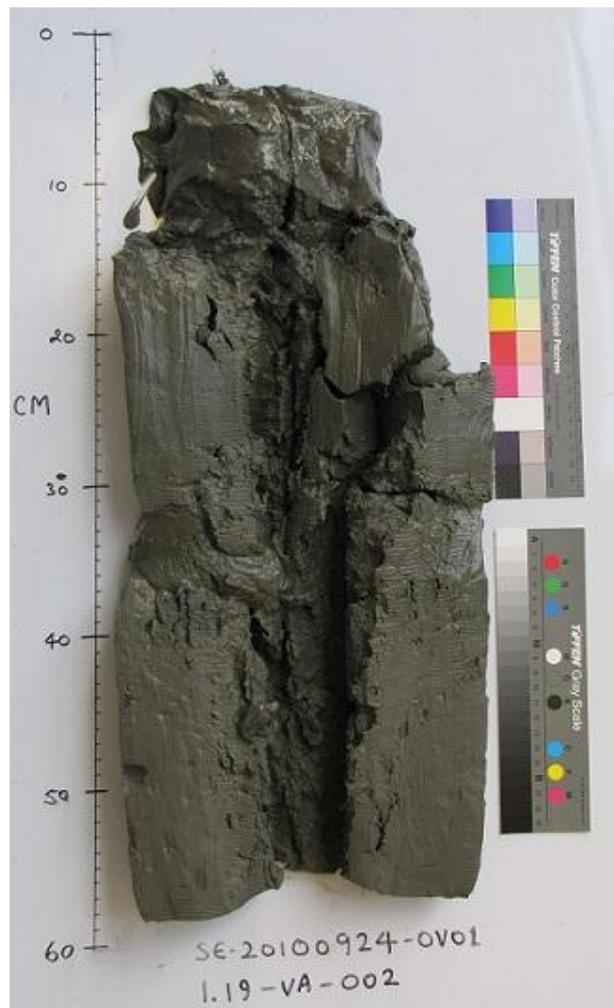
Station 1-19

Visible contamination: None

Olfactible contamination: None

Description: Approx 30cm very soft olive/brown silty clay, gradual transition to 20cm soft olive/brown clay. Top 0-3 cm not examined as given to GC/MS for analysis.

Gas Chromatography & Mass Spectroscopy: The top 3cm of sediment core was sampled and analysed for EPA priority pollutant PAHs and Corexit 9500 dispersant. The sample was also screened for the source oil fingerprint. None of the target analytes were detected. No source oil was detected.

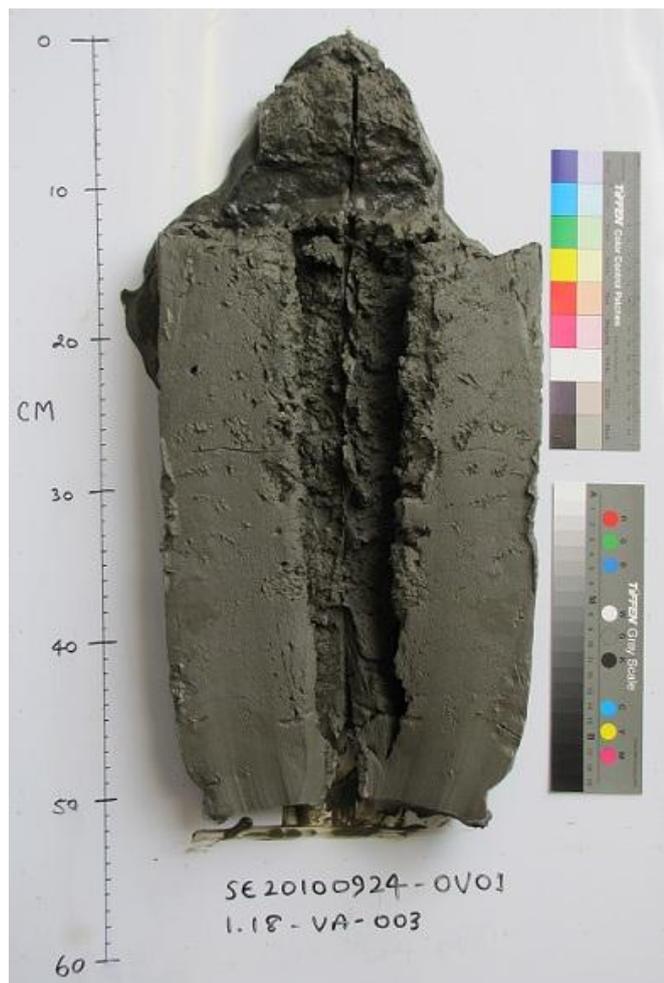
Station 1-18

Visible contamination: None

Olfactible contamination: None

Description: Approx 5cm very soft olive/brown silty clay, gradual transition to 45cm soft olive/brown clay. Top 0-3 cm not examined as given to GC/MS for analysis.

Gas Chromatography & Mass Spectroscopy: The top 3cm of sediment core was sampled and analysed for EPA priority pollutant PAHs and Corexit 9500 dispersant. The sample was also screened for the source oil fingerprint. None of the target analytes were detected. No source oil was detected.
